REPORT ON VELOCITY TRANSDUCER FAILURES  
INTERMOUNTAIN POWER, DELTA UTAH  
COOLING TOWER FAN MONITORING SYSTEMS

PREPARED BY  
JOHN WARNER  
BENTLY NEVADA TRANSDUCER ENGINEERING  
BENTLY NEVADA CORPORATION  
MINDEN, NEVADA

12 JANUARY 1988

for  
WES BLUMFIELD  
INTERMOUNTAIN POWER SERVICE CORPORATION  
DELTA, UTAH

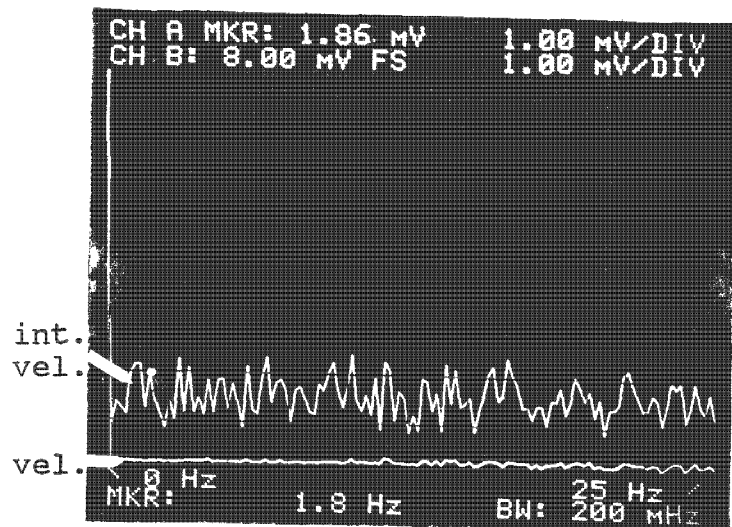
PHOTO #1 S/N J304982

In evaluating the transducers returned, it was found that the signal path in S/N '958 and '982 was shorted to the case. If a shorted transducer and its monitor are not earth grounded, the OK LED will remain illuminated and any extraneous noise present on the machine case will be coupled to the transducer signal and amplified at the monitor. In the lab at Bently Nevada a signal from a noise source was attached to the case of S/N '982. Photo #1 shows the output, both velocity and integrated velocity, of S/N '982 through a low frequency vibration monitor's buffered A and B output. This simulates any installation of a shorted coil transducer on an ungrounded machine which has some noise present. In the same conditions as photo #1, the velocity and integrated velocity output of an earth grounded transducer whose coil is not shorted would have zero output.

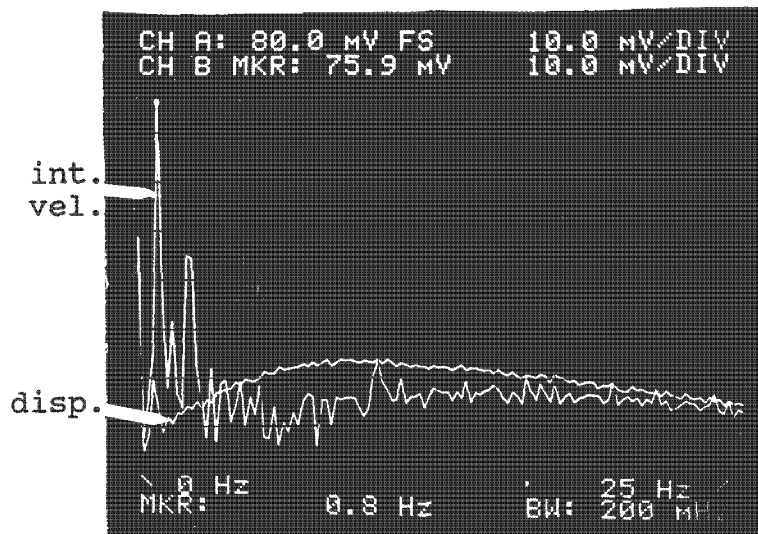
PHOTO #2 S/N J304968

The other failure mode discovered in 2 units, S/N '968 and '969,

is due to the transducers internal moving mass contacting the stationary components inside. This is termed "drag". Because drag is orientation sensitive, a "good" unit in one installed angular orientation may be "bad" in other orientations. Photo 2 is S/N '968 comparing a proximity displacement transducer signal to the integrated velocity signal from a velocity transducer having drag. At 0.8 Hz the amplitude of the integrated velocity is 75.9 mV while the actual displacement amplitude is less than 10 mV. Photo 3 is of the same conditions but with the seismoprobe rotated by unscrewing it from its mounting (counterclockwise) 15°. Photo 4 is rotated (counterclockwise) 30° from photo 2. In photos 2 and 3 the transducer is in its drag orientation, photo 3 approaching the non drag condition of photo 4. It can be seen that installed orientation affects the degree of drag and contributes to variations in indicated machine vibration.
